Relationship Between Timber Bridge Characteristics and Asphalt Pavement Wear Surface Performance

Minnesota Local Road
Research Board

1. Report No. 1998-07		2.		3. Recipient's Accession No.	
4. Title and Subtitle RELATION BETWEEN TIMBER BRIDGE CHARACTERISTICS AND ASPHALT PAVEMENT WEAR SURFACE PERFORMANCE				5. Report Date June 1997

Final Report Literature Review

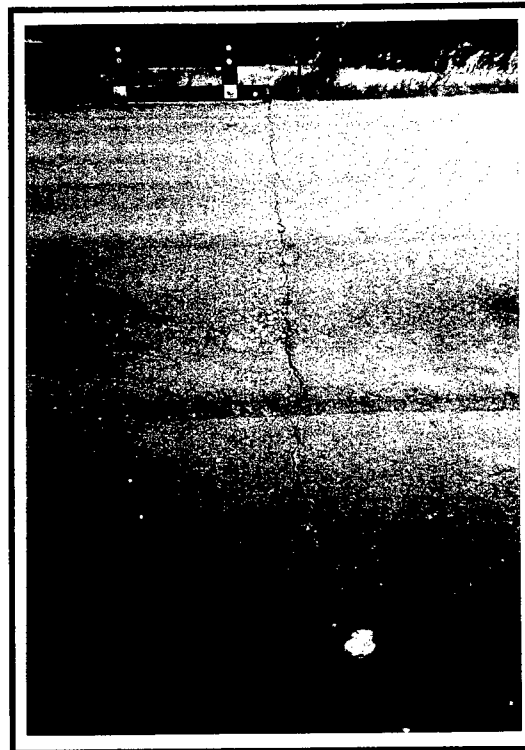
bridge pier-cap supports, as seen in this overhead view (Figure 2.2), notice the pier cap support extends past the edge of the bridge deck and the pavement crack has formed nearly on center with the cap. Also, transverse cracks appear at end of the decks over the abutment-cap support (Figure 2.3). An exception to transverse crack

Figure 2.3 Transverse Pavement Crack Over Deck Abutment Cap Support

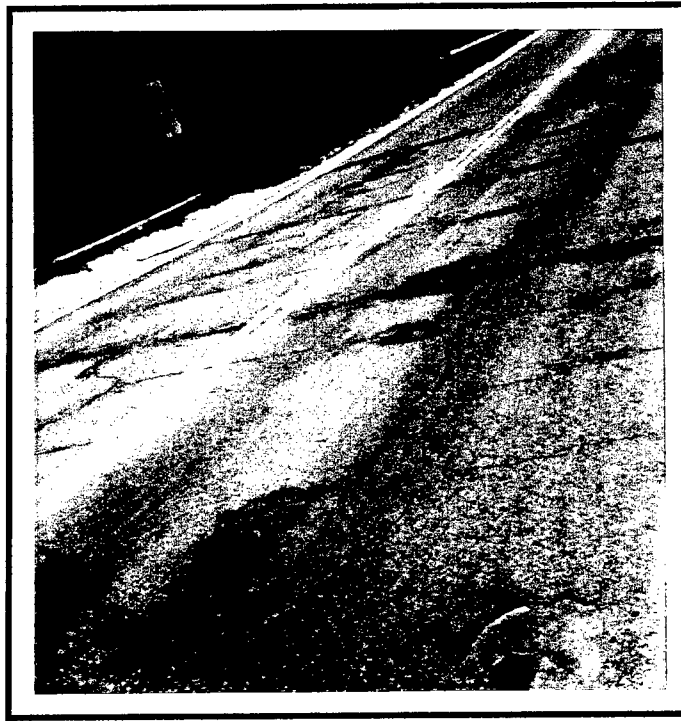
Asphalt fatigue including “alligator” cracking, asphalt de-bonding and pavement raveling was observed in various locations across the timber decks. The worst cases of fatigue seemed to be in proximity to existing transverse and longitudinal pavement cracks (Figure 2.5 and 2.6). While the mechanical nature of the timber deck was determined to be largely responsible for initial transverse and longitudinal pavement crack formation due to independent movement among deck panels and laminations [Ken Johnson, P.E., Wheeler Consolidated, Inc. and Gene Isakson, P.E., Sibley County, MN], the severe pavement distress surrounding these cracks is likely a result of the pavement mix design rather than bridge deck performance. According to Dr. David Newcomb [Associate Professor, Department of Civil Engineering, University of Minnesota], asphalt deterioration is commonly influenced by the presence of excessive pavement voids due to improper pavement mix design or inadequate compaction. Proper asphalt compaction on timber bridge decks is difficult because only small compactors can be used. Excessive percent pavement voids can affect pavement durability through both diminished asphalt adhesion to the aggregates and increased pavement susceptibility to moisture damage. Dr. Newcomb attributes pavement voids to insufficient quantities of asphalt binder presence in the mix and improper pavement compaction. New pavement design specifications incorporate higher quantities of asphalt and higher compaction standards, when these design requirements are followed much of the asphalt fatigue should be effectively reduced. Also the sever cracking observed in **Figure 2.4** may be attributed to poor asphalt adhesion due to inadequate tack coat application on the deck prior to paving (John Isackson, Mn/DOT Road Research). Under conditions of poor adhesion the asphalt may move free from the deck which may allow excessive cracking during deck deflection.

Figure 2.6 Asphalt Fatigue and De-Bonding interactions.
